InspectNOW

Subject Property:

123 Backwards St.
Hudson, WI 54016

Report # : SU 3-7-05

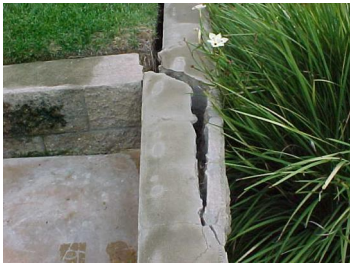
03. Retaining Walls

Comments: Major cracks and displacement; recommend further evaluation by a structural or geotechnical engineer and repairs as needed. (1) (2) *** See Picture 03 on Photos Page ***

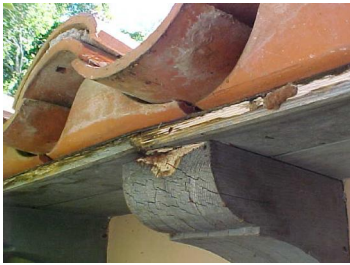
10. Trim

Comments: Moisture damage noted at the eaves. (2) (3) *** See Picture 10 on Photos Page ***

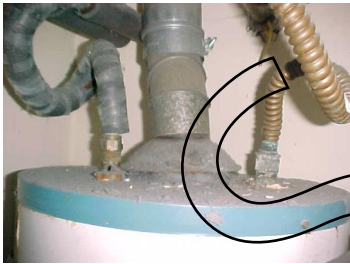
27. Water Heater(s)

Comments: Recommend further evaluation and repairs by a qualified professional. (2) (4) The water heater vent (draft hood) is damaged. (2) The water heater vent was back drafting. Products of combustion were spilling from the draft diverter. (2) (4) Damaged platform, water heater not properly supported. Hole in heater return air plenum. (2) (4) *** See Picture 27 on Photos Page ***

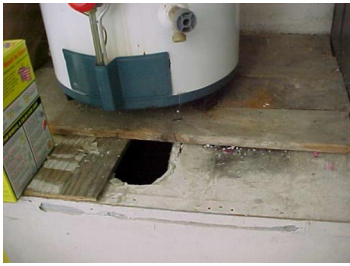
31. Combustion Air	Safety Hazard	<input checked="" type="checkbox"/> Deterioration / Damage (2)
<input type="checkbox"/> Near end of lifespan (2) <input type="checkbox"/> Not functional (2) <input type="checkbox"/> Combustion air: <input type="checkbox"/> Combustion and return air are too close or mixing (2) (4) <input type="checkbox"/> Recommend sealing holes / gaps in platform * (4)		
<u>Comments:</u> Large hole in return air platform, pulling return air from garage. (2) (4) Recommend sealing platform at heater base. (2) *** See Picture 31 on Photos Page ***
